Home Inspection Report

Any Old Street, Sterling, IL 61081

170304.10

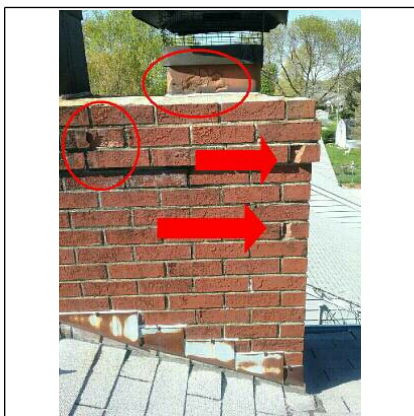
Comments Brick face is popping off - recommend a qualified contractor evaluate and repair.
Missing/loose mortar in the brick joints. Recommend tuck-pointing.
Chimney flue was not accessible, so not evaluated.

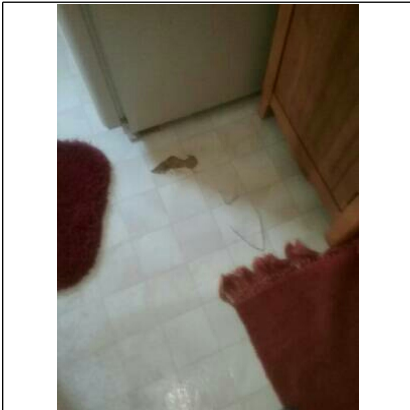
Comments Tear in linoleum floor near entry to garage.

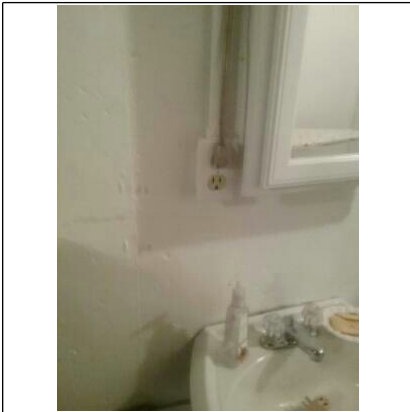
- Heat source present** Yes No
- Exhaust fan** Yes No Operable: Yes No Noisy
- Comments** Recommend GFCI within 6' of water.
 Several outlets have reverse polarity. Recommend contacting a licensed electrician to correct.
 These are both safety issues.

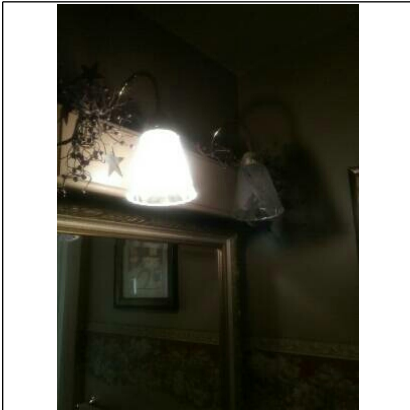
- Sinks** Faucet leaks: Yes No Pipes leak: Yes No
- Toilet** Bowl loose: Yes No Operable: Yes No Cracked bowl Toilet leaks
- Drainage** Satisfactory Marginal Poor
- Water flow** Satisfactory Marginal Poor
- Moisture stains present** Yes No Walls Ceilings Cabinetry
- Doors** Satisfactory Marginal Poor
- Window** None Satisfactory Marginal Poor
- Receptacles present** Yes No Operable: Yes No
- GFCI** Yes No Operable: Yes No Recommend GFCI
- Open ground/Reverse polarity** Yes No Potential Safety Hazard
- Heat source present** Yes No
- Exhaust fan** Yes No Operable: Yes No Noisy
- Comments** Light above sink is broken and should be replaced.

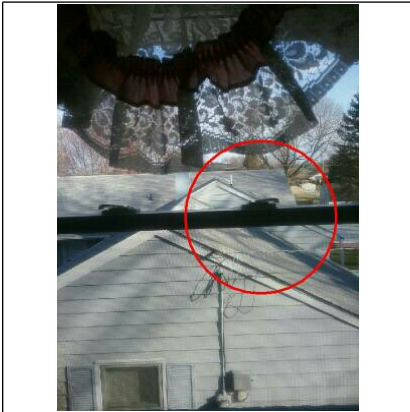
- Heat source present** Yes No
- Exhaust fan** Yes No Operable: Yes No Noisy
- Comments** Right window latch will not turn. Suggest replacing latch to properly lock window.

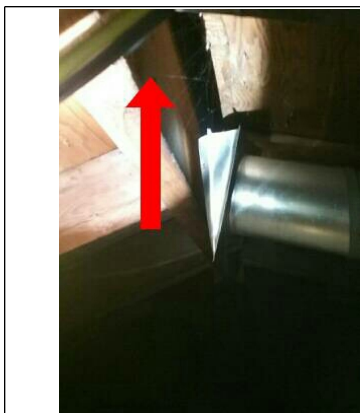
Exhaust vent should extend through roof.

Comments Insulation was marginal and could be upgraded.
 Recommend extending bathroom vents to the exterior.
 Could not view entire attic due to condensation unit for air conditioner.

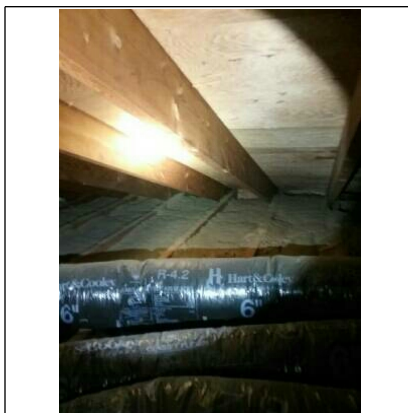
Suggest adding addition insulation.

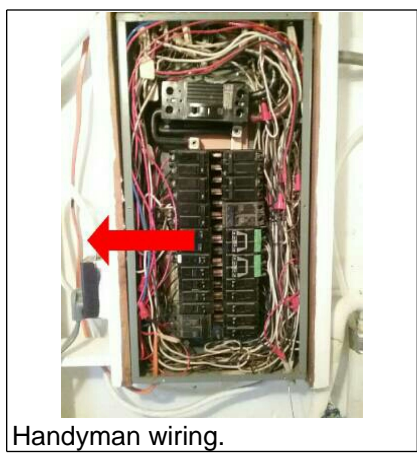
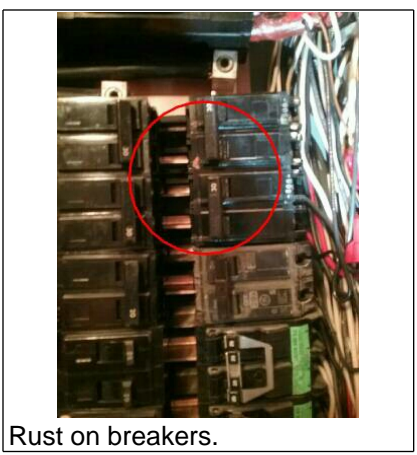
Comments Handy man wiring present - recommend a licensed electrician evaluate, repair and replace as necessary. Evidence of rust in panel.
 Several breakers are double-tapped - this is a safety concern. Recommend licensed electrician evaluate and make necessary repairs.

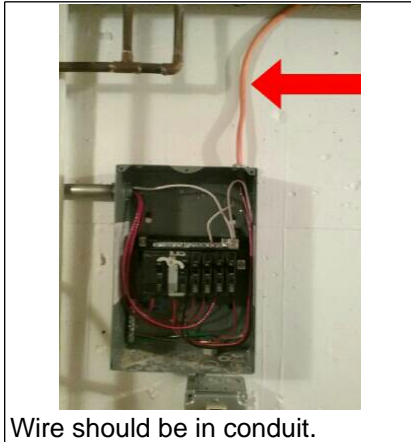
Wire should be in conduit.

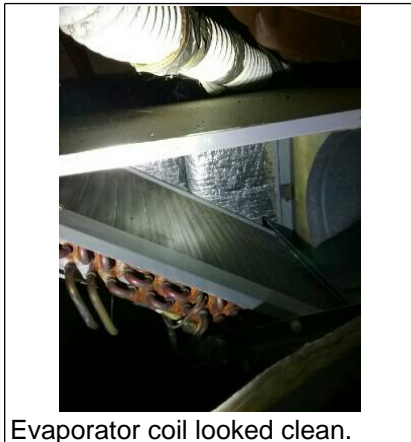
Evaporator coil looked clean.

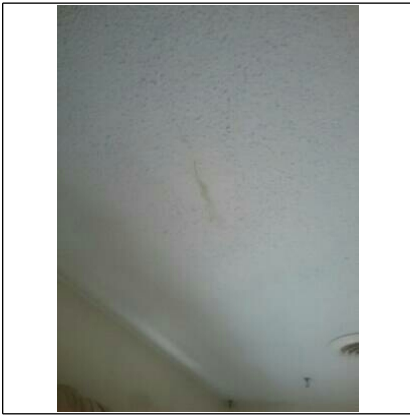
Where: Crack in the ceiling due to water damage. Suspect water from tub on second-story. Tested with moisture meter. Leak is not active. Continue to monitor.
